MAY 2024 FLOODS IN ARMENIA:

Documenting and Understanding Disaster in
Lori and Tavush regions, 24–26 May 2024

EVENT ANALYSIS

**EDUCATIONAL COMPLEX OF THE MINISTRY OF INTERNAL AFFAIRS
OF THE REPUBLIC OF ARMENIA SNCO**

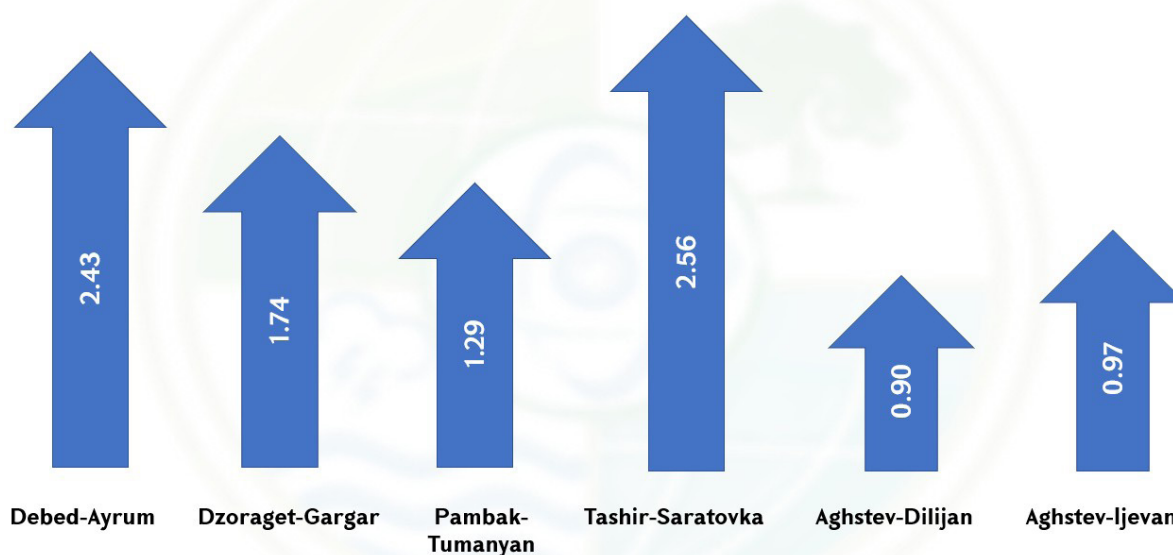
The amount of water-level rise in metres at the observation points on 26 May, compared to 08:00 on 25 May.

Figure 8. Rise of water level at different observation points

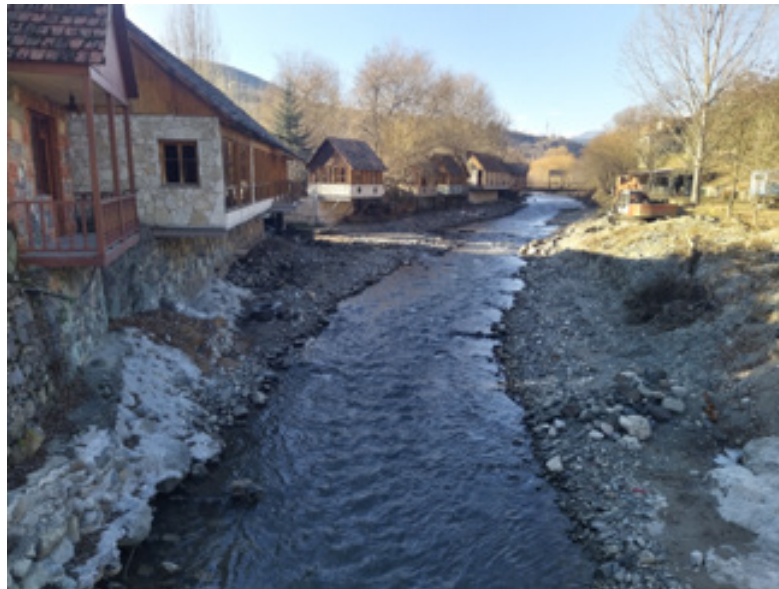
Image 1. Buildings at the riverside

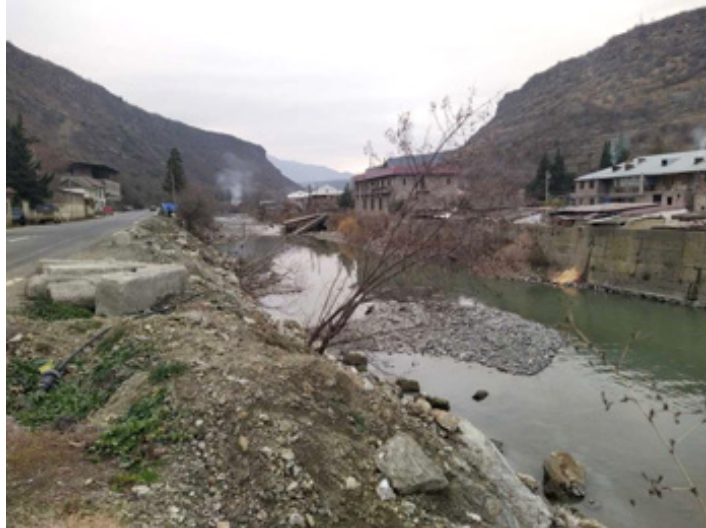
The high discharges led to a high amount of sediment transport in some stretches along the rivers. Sediment deposits on and beside the riverbed alternated with bed and bank erosion. This led to the destruction of various sections of the roads along the river (Image 4).

Image 4. Destroyed road at Karkop

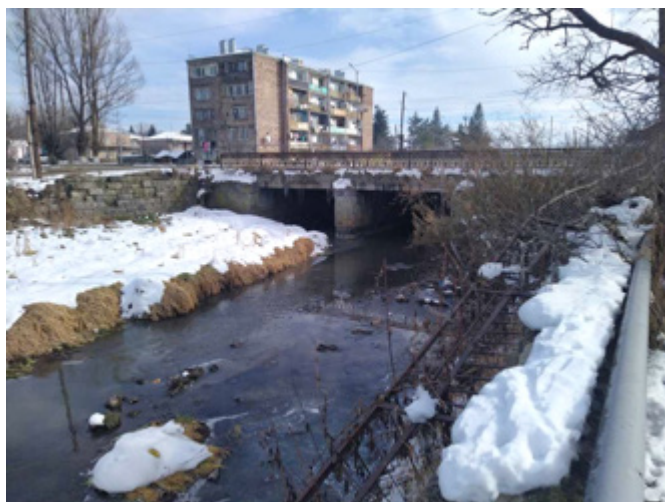
Image 5. Tashir river with accumulations in the river bed

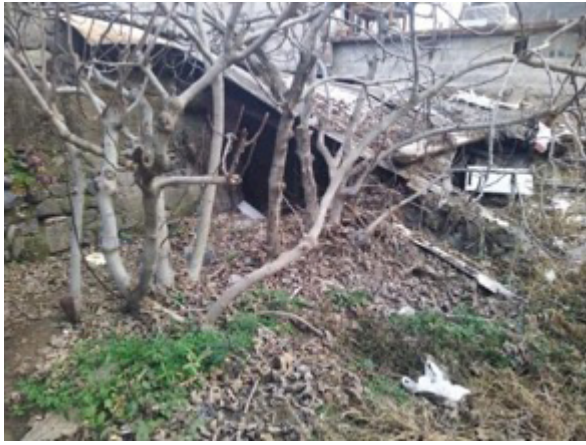
Image 6. Wall with hole were water entered the village of Karkop

In order to prevent further flooding of the village, the wall will need to be repaired. If a bridge to the village were rebuilt at the same location, it should be planned with no piers and be strongly anchored to the terrain at both ends. If a pier were to prove necessary, it should have deep foundations in the riverbed. Modelling (e.g. HEC-RAS) can be used to determine the required level of the bridge so that the channel has sufficient discharge capacity in the event of flooding.

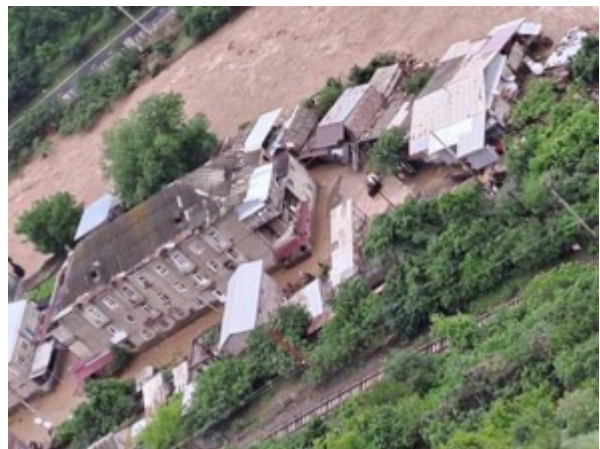
Image 9. Karkop during the flood

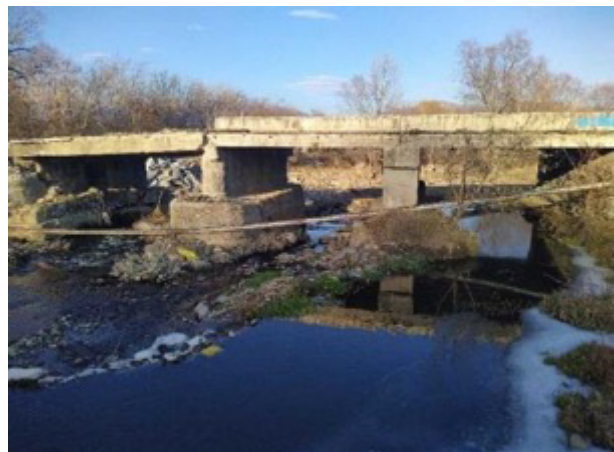
Image 11. Hobardzi bridge

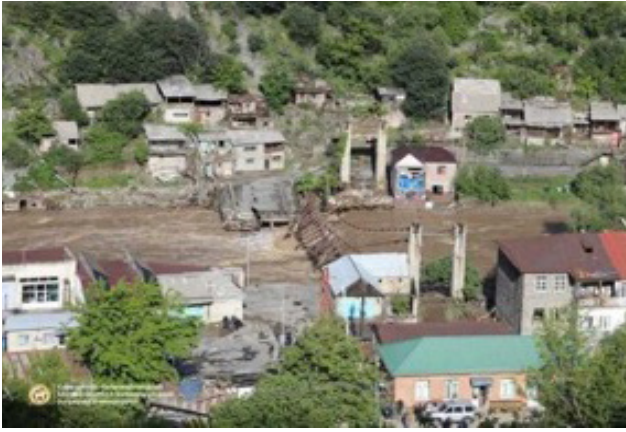
Image 12. Destruction of the bridge at Sanahin

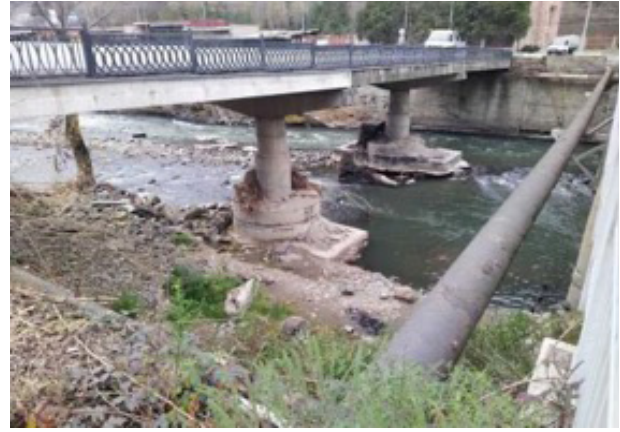
Image 13. Undercut piers of bridge in Alaverdi

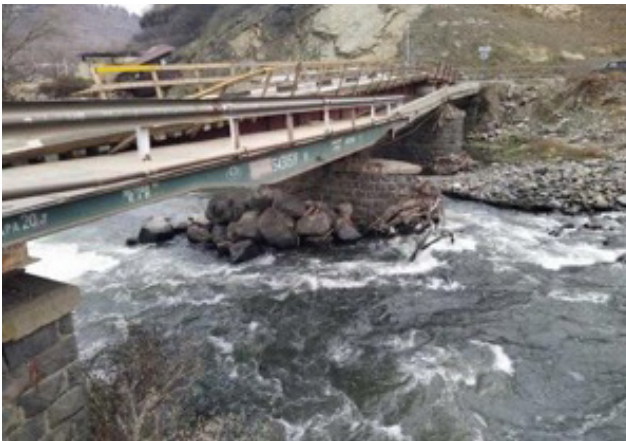
Image 14. Akhtala bridge

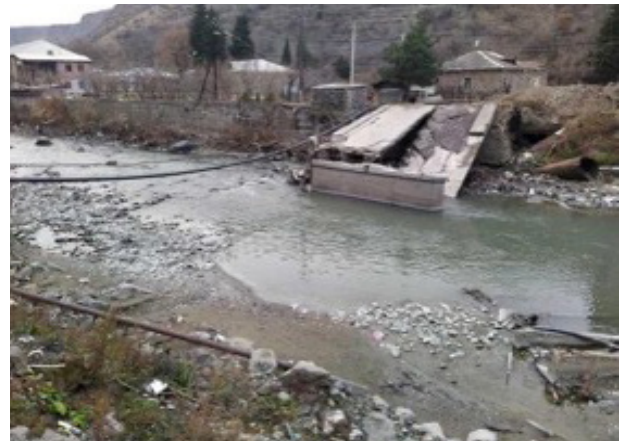
Image 15. Destroyed bridge in Karkop village

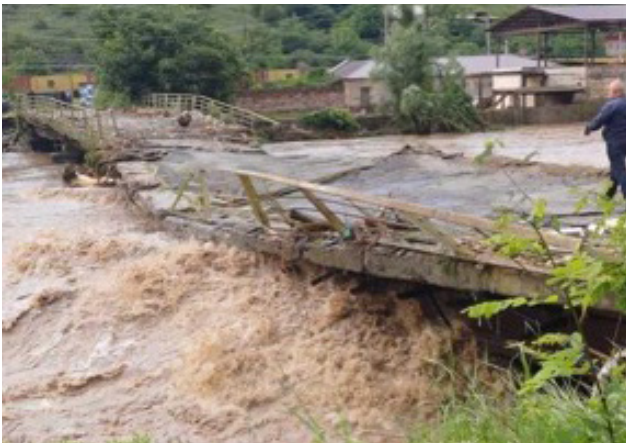
Image 16. Ayrum bridge during the flood

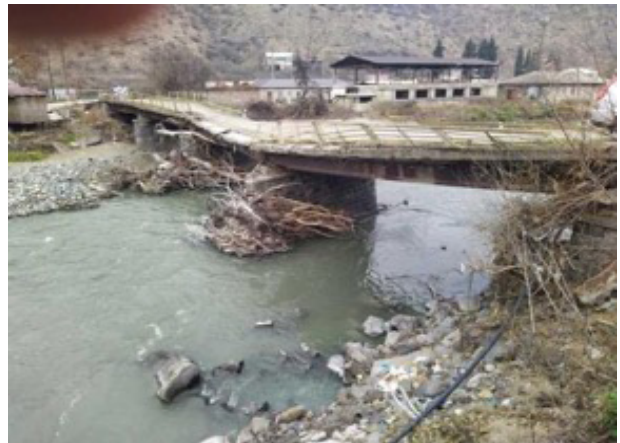
Image 17. Ayrum bridge in December 2024

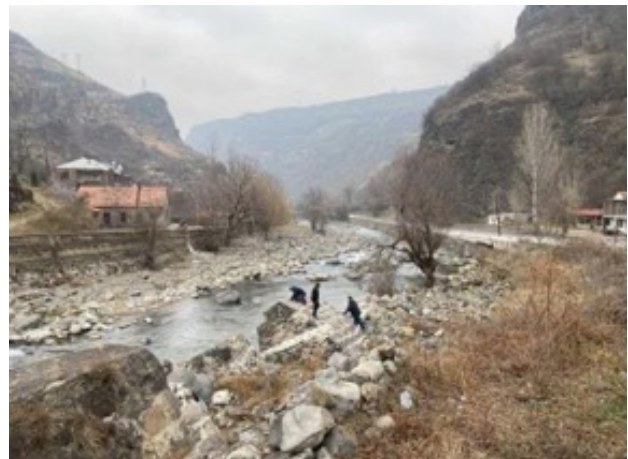
Image 19. Collapsed bank protection works below the confluence of Pambak and Dzoraget rivers

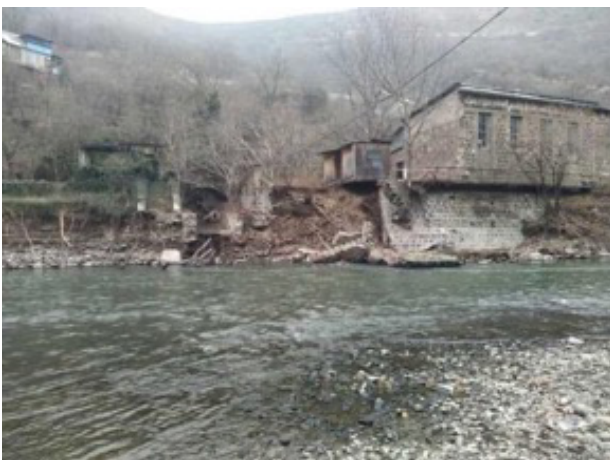
Image 20. Debed river with destroyed bank protection works at Sanahin

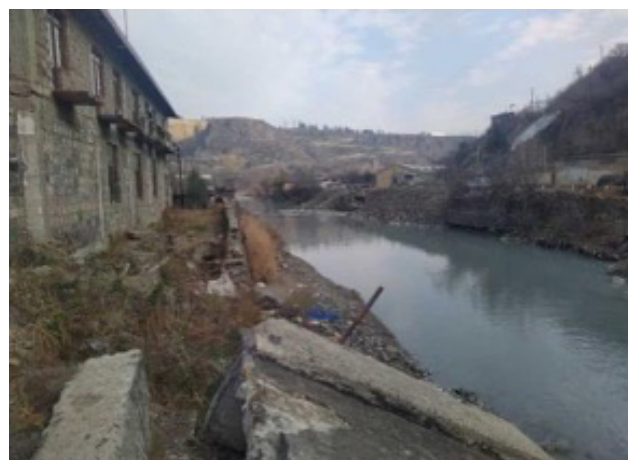
Image 21. Destroyed bank protection works at the right side of Debed river at Karkop

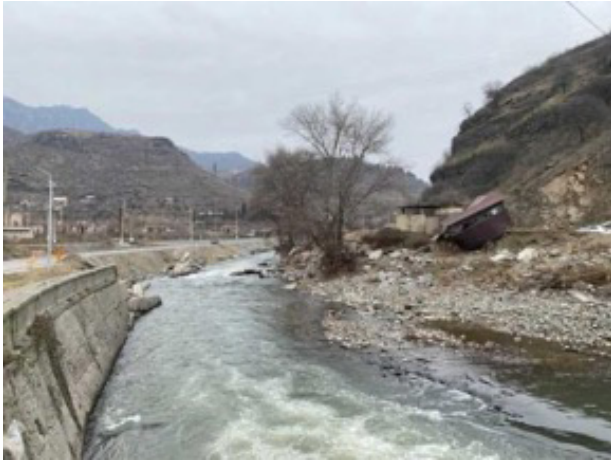
Bank or lateral erosion occurred where the river was diverted around an obstacle, encountered a construction or hit a bank (Image 22 and Image 23). The eroded bank in Image 24 did not cause any direct damage, but the presence of the dam meant that a large amount of sediment was deposited, making the river downstream highly erosive again.

Image 22. Debed near Akhtala village

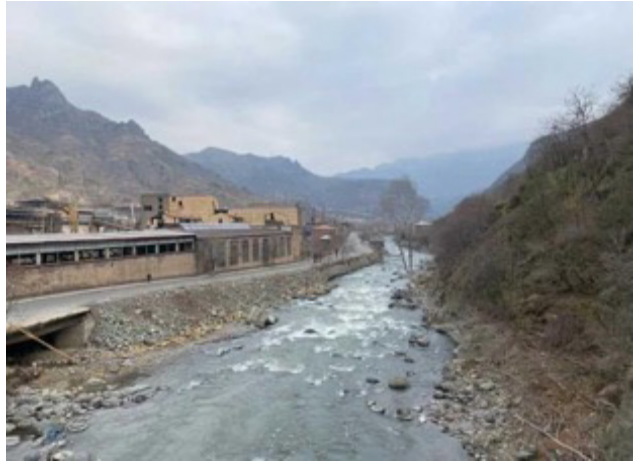
Image 23. Debed in Alaverdi

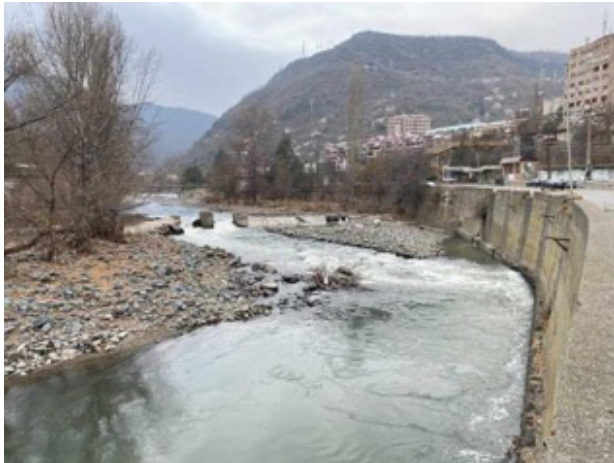
Several hundred metres downstream of the Alaverdi bridge are the remains of a dam. Its function was not clear during the field excursion. In the two openings, there might previously have been frame weirs. Nevertheless, the effect of this dam is that the water is diverted directly to the left of the embankment (practically at a right angle, Image 25). It is expected that the embankment will be undercut and therefore fail in the future, as happened some metres downstream during the flood event (Image 26). However, because so much water flowed over the dam, the openings played a minor role. The derived water undercut the wall and it collapsed and was washed away (Image 26). In conclusion, it might be stated that the dam is counterproductive and endangers the bank protection walls on the orographic left side. If there is no other important reason to keep the structure, the removal of the dam is recommended.

Image 25. Remains of a dam diverting water to the protection wall

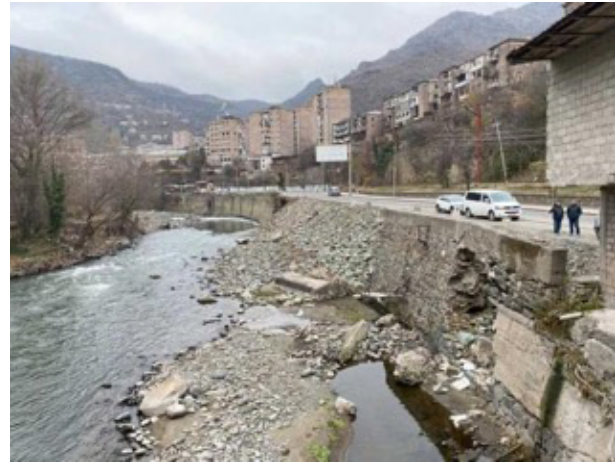
Image 26. Collapse of the protection wall downstream of the dam

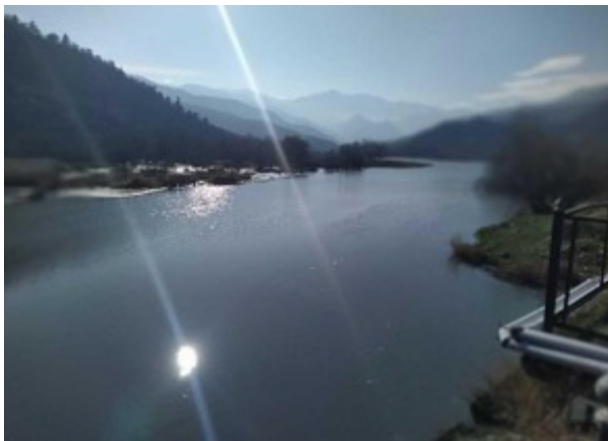
The effect of the reservoir during the May 2024 flood was not quite clear. Some additional frame weirs obviously existed prior to the flood, damming the water up to the road before breaking. Some remains of the frame weirs are still present, but it could not be determined in detail how exactly the process of destruction started. It was assumed that the damming process in the reservoir did not significantly affect the peak discharge for Ijevan a few kilometres downstream.

Image 27. Ijevan Reservoir

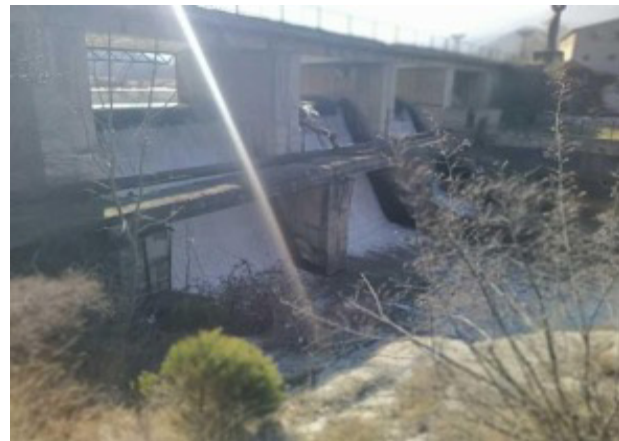
Image 28. Dam at the Ijevan reservoir

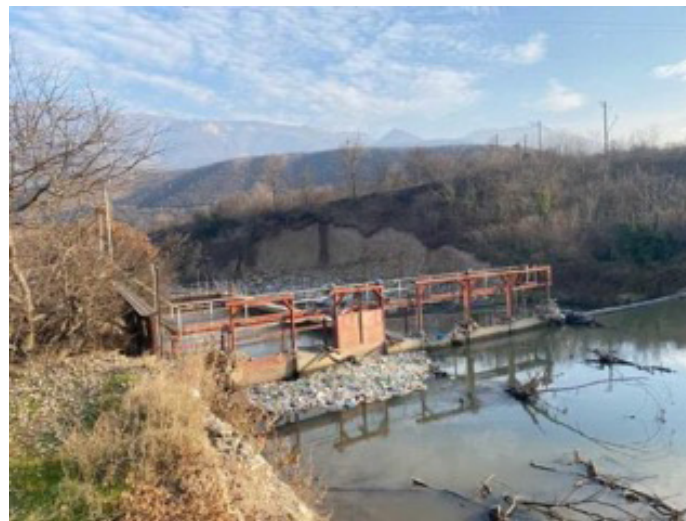
Downstream of the dam, due to the sediment deficit, the river was further eroded. This effect favoured erosion of the right bank downstream (Image 29) and scour and undercutting of the Khashtarak bridge several hundred metres downstream.

Image 29. Dam upstream of Khashtarak bridge

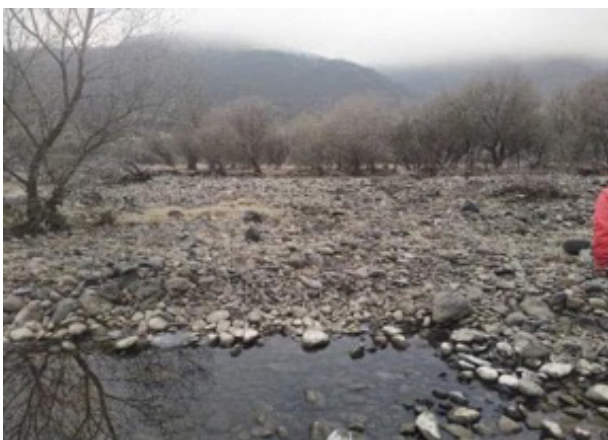
Image 30. Floodplain upstream of the reservoir

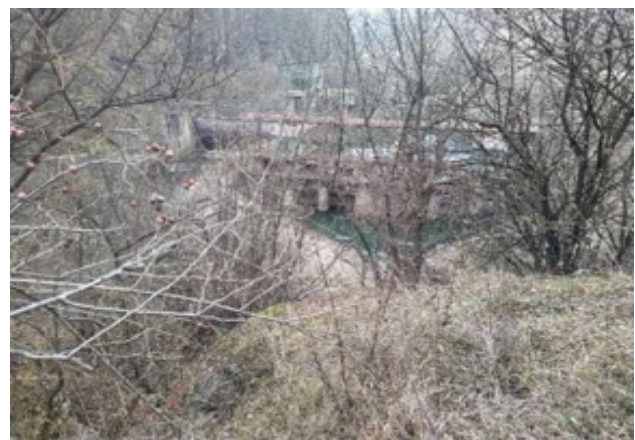
The river bed below the reservoir seems stable, and contains many coarse boulders. It could be assessed that the bedload input from Dzoraget to the Debed river was not significant.

Image 31. Reservoir of Dzoraget river

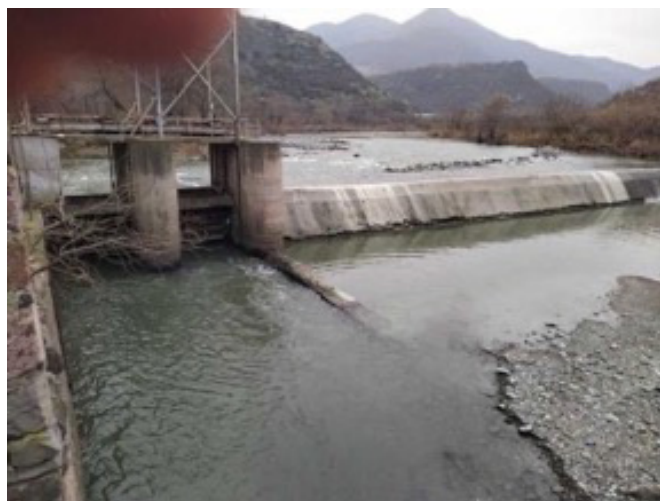
In the event of a flood, the dam at Shnogh reservoir retains sediment, but with limited influence on discharge.

Image 32. Dam at the Shnogh reservoir

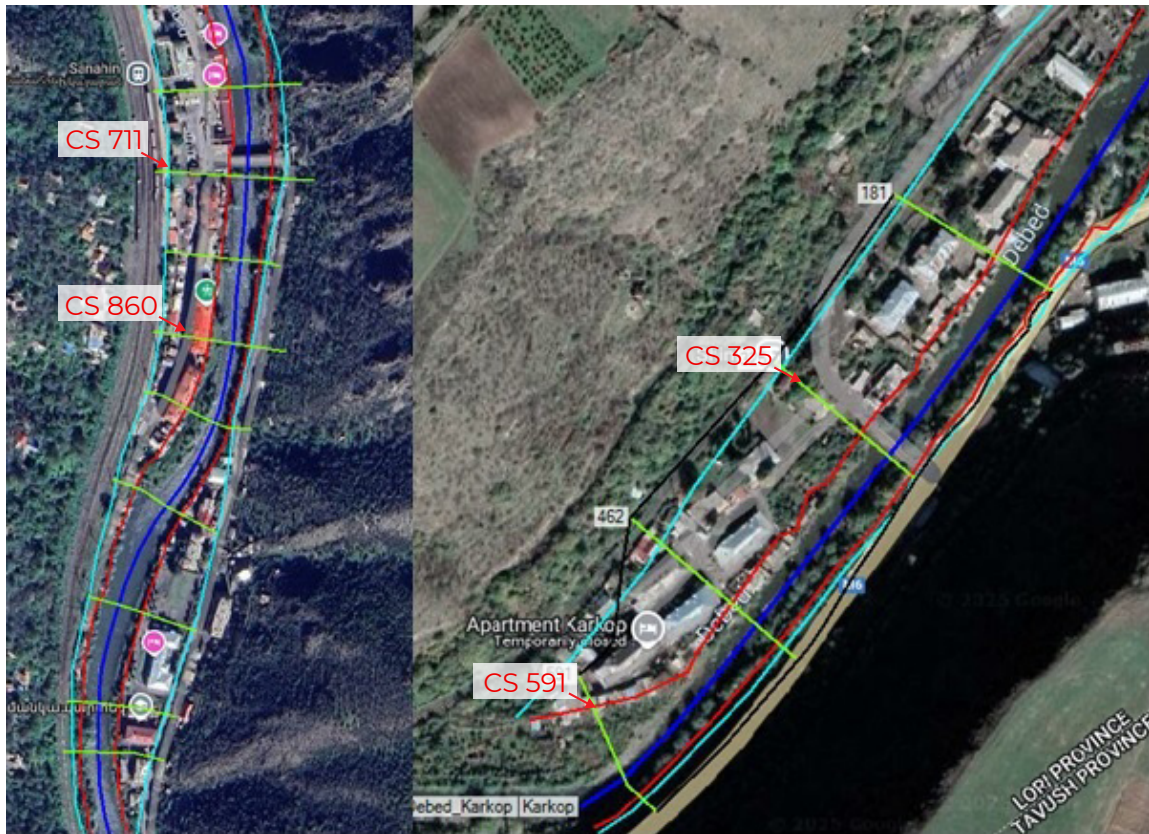
Figure 12 shows the HEC-RAS model set-up in Sanahin station (left) and Karkop (right) – RAS mapper view: blue = river axis, green = cross sections, red = bank lines, turquoise = flow paths. CS 860, Sanahin = cross section at the location of observed damage in the building, with water level 2.5–3m higher than the surrounding ground (see Figure 13 and Figure 14), CS 711, Sanahin = cross section at the destroyed bridge (see Image 33). CS 591, Karkop = cross section at the entrance of the village where holes have been observed in the protection walls (see Figure 15). CS 325, Karkop = cross section of destroyed bridge in Karkop (see Figure 16).

Figure 12. HEC-RAS model

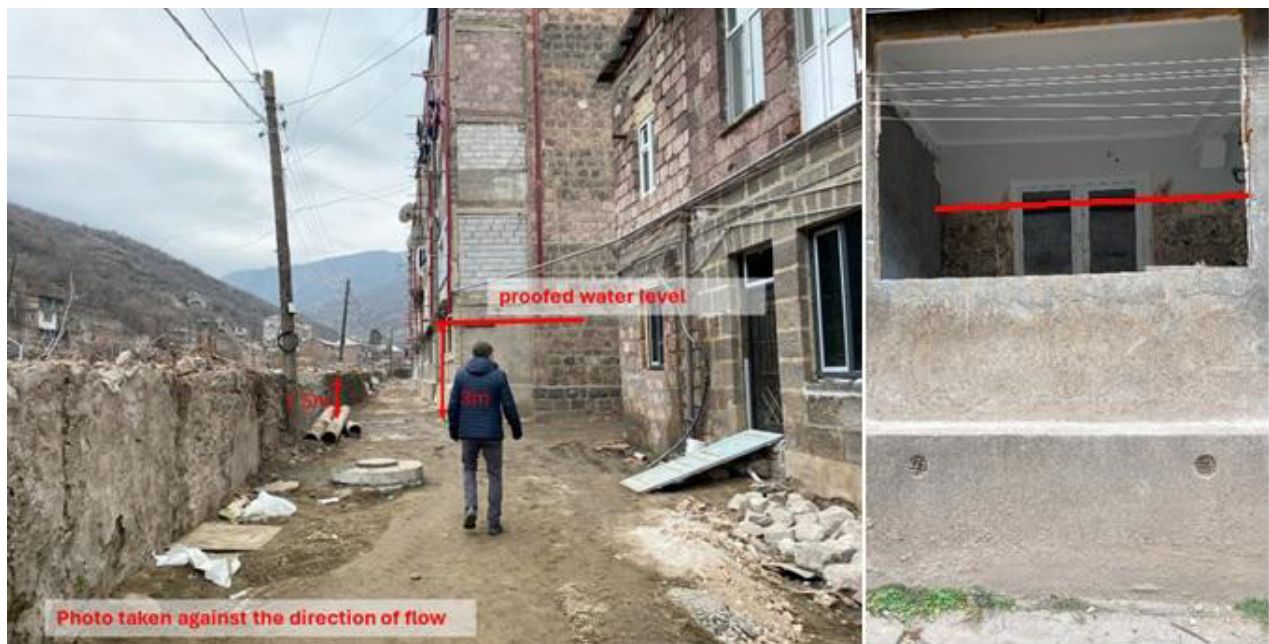
imum water level during the event (see Figure 13). In the high-resolution terrain model, the river protection walls of the River Debed in the settlement area were not correctly included. This was adjusted as shown in Figure 14. According to the model, the reconstructed water levels can be achieved with free-flowing discharges of around 700–800m³ (level of energy line).

Image 33. Height of protection wall and damages / proofed water level compared to path on the west bank of Debed river in Sanahin station.

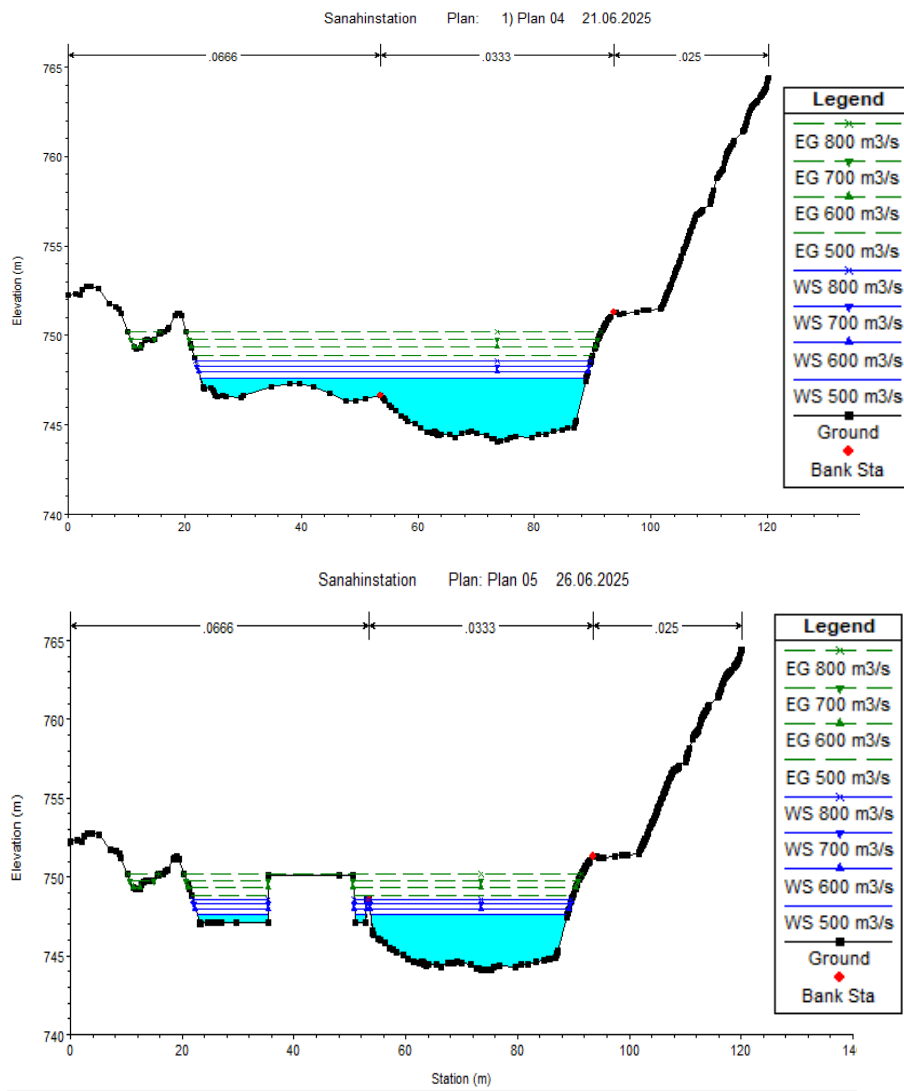
Figure 13-14. Cross section in HEC-RAS model at the location of Image 33.

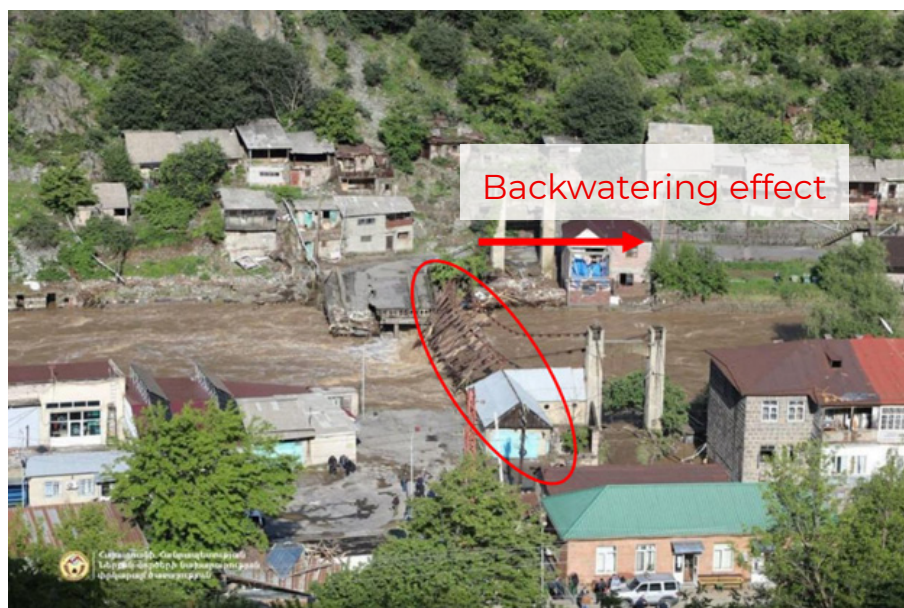
In Sanahin station, however, there were considerable backwater effects due to the damaged bridge, which increased the water level upstream (see Image 34). In addition, the sediment transport is not taken into account in the modelling. The transported sediment increases the flow area for the same volume of water and reduces the flow velocity. As explained above, the sediment dynamics were important in the event and are also likely to have played a role in Sanahin station, albeit a comparatively small one due to the shallow gradient in the settlement area. Even if the recalculation of the event is difficult due to the dynamic of sedimentation and erosion in the riverbed during the event, it can be concluded for the reasons stated that the proofed water level in Figure 13 was not reached by discharges of 700-800m³/s but by a smaller peak discharge in the order of around 600m³/s.

Image 34. Backwatering effect through damaged bridge in sanahin station:

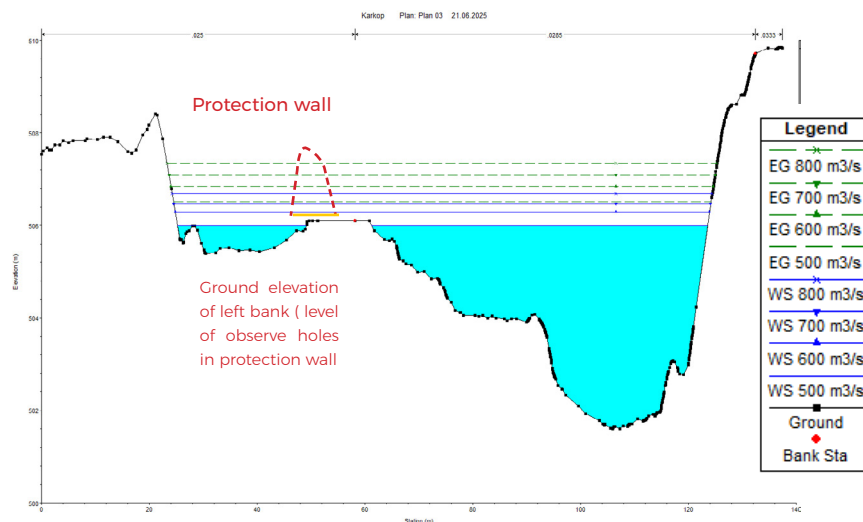
The catchment area of the River Debed in Karkop is 3,660km² (99% of the area of the catchment area of the River Debed for the Ayrum hydrological observation station). In Karkop, the holes in the riverbank protection wall played a significant role in the flooding of the southern part of the settlement. These holes were discovered during the field inspection in December 2024 (see Image 7 and Image 8). The geometry in the HEC-RAS model was adjusted so that the ground elevation of the left bank was reduced to the height of the hole. Figure 15 shows that with well-functioning riverbank protection walls, discharges of 800m³/s would stay within the channel and would not lead to riverbank overflow in this specific cross section at the entrance of the village of Karkop (cross section 591, see Figure 15). Taking the hole into account (node in model 506.10 m.a.s.l.), small water outflows occur from a discharge of 500m³/s – the energy line is 0.4m higher than the opening of the hole at this peak discharge. For discharges of 600m³/s, 700m³/s and 800m³/s, the water level and the energy line increase steadily (see Table 2) and the water outflow through the hole into the southern settlement also increases. This cross section does not allow an exact recalculation of the peak discharge during the event in May 2024, but it gives a good idea of the minimum peak discharge that occurred in the event.

Figure 15. HEC-RAS geometry for cross section 591 in Karkop (southern entrance of the village) including modelled water level and energy line level for discharges between 500-800 m³/s. Geometry of entire cross section including channel and settlement area. Ground elevation of left bank in model corresponds to level of observed holes in protection wall. Protection wall above the holes was not considered (red dashed line).

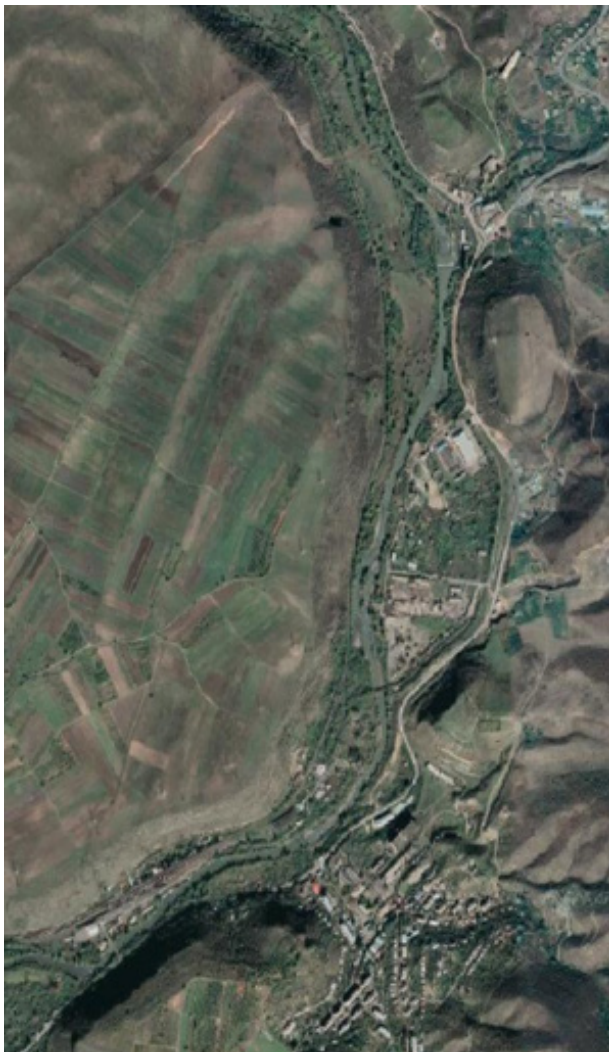
The satellite images were obtained from Planet's PlanetScope satellite. These data served as the primary source for determining the extent of the flood. The images were captured on 28 May 2024. This analysis focused on the Debed river basin, which caused the most significant damage.

Image 35. Ayrum Settlement Area: April, 2023. (comparative)

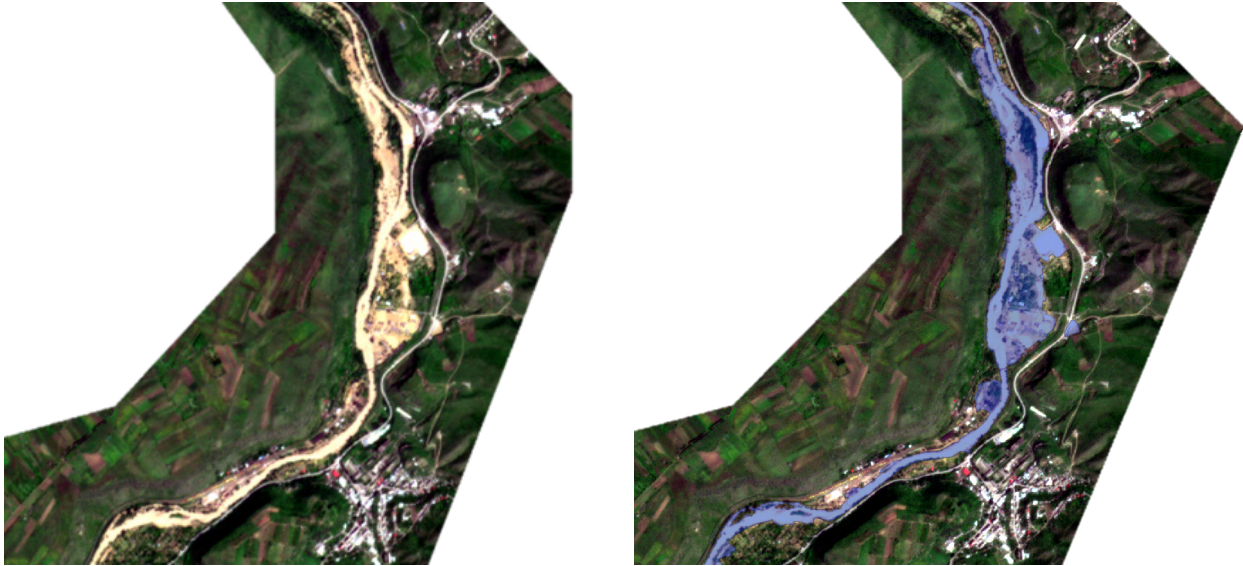
Image 36. Ayrum Settlement Area: May 28, 2024 (flooding)

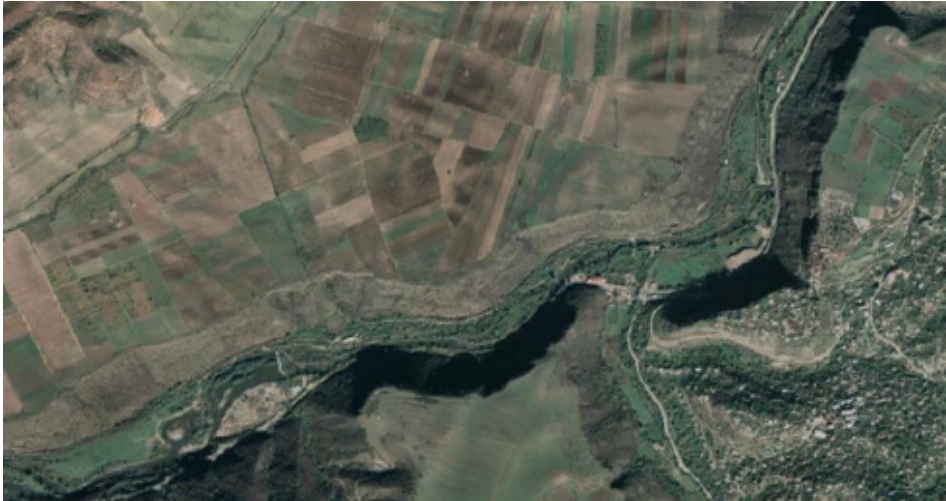
Image 37. Shnogh Settlement Area: April 2023 (comparative).

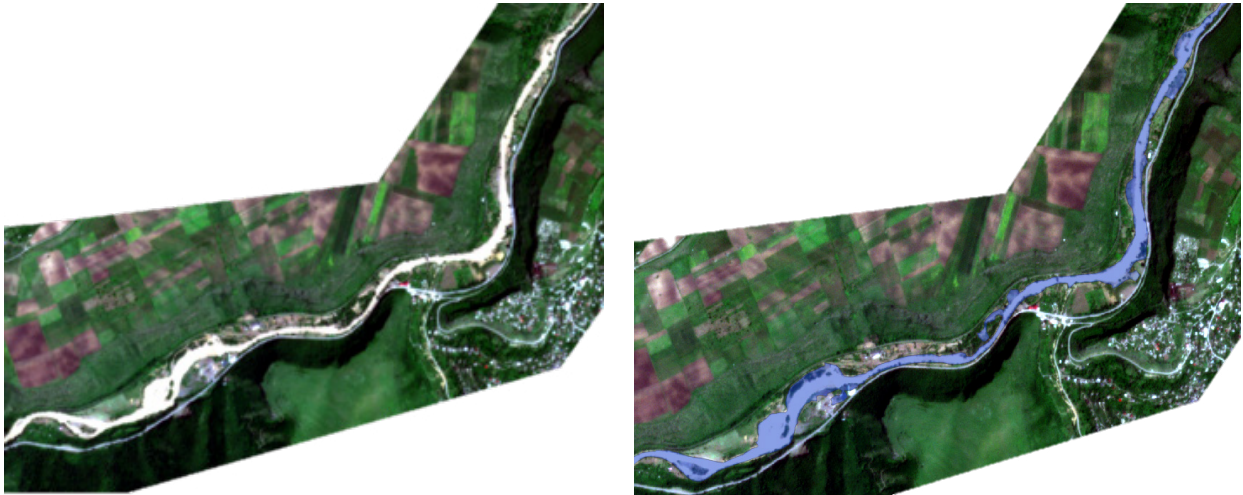
Image 38. Shnogh Settlement Area: May 28, 2024 (flooding)

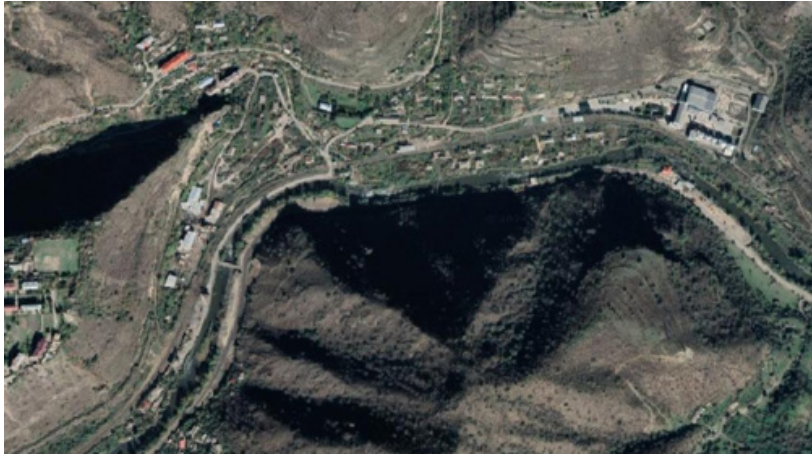
Image 39. Akhtala Residential and Industrial Areas: April 2023 (comparative).

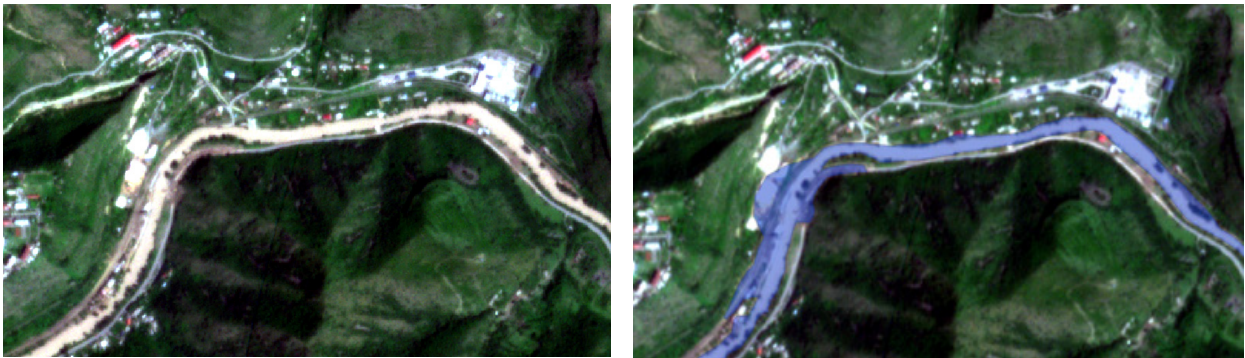
Image 40. Akhtala Residential and Industrial Areas: May 28, 2024 (flooding)

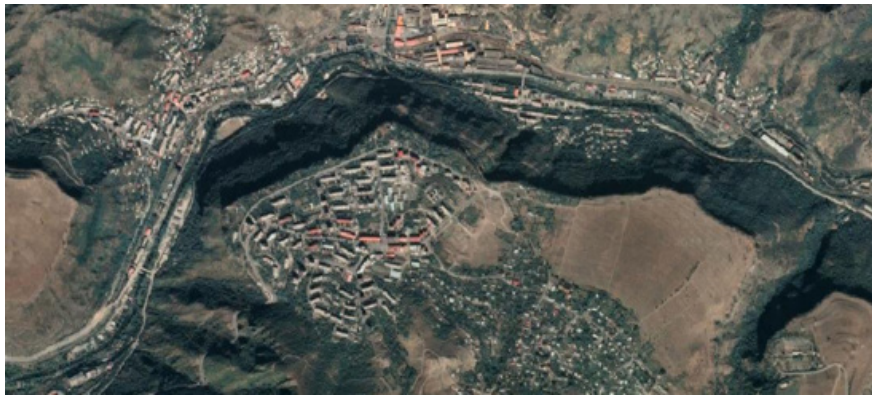
Image 41. Alaverdi Settlement, Bridges: April 2023 (comparative).

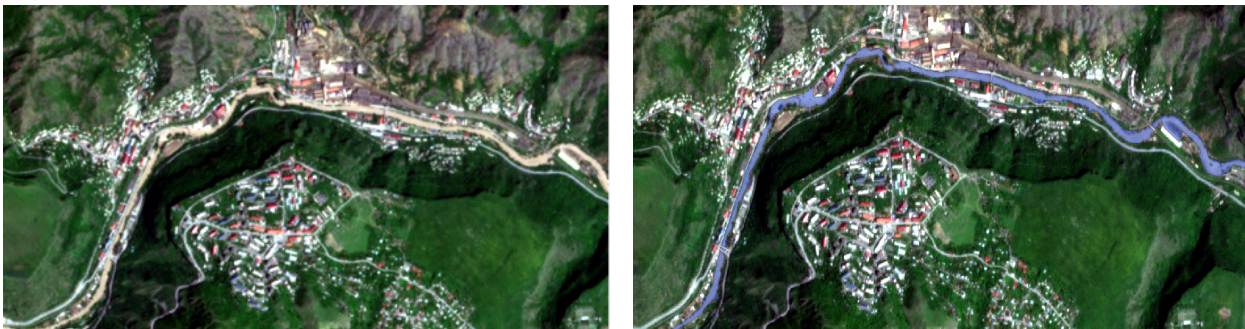
Image 42. Alaverdi Settlement, Bridges: May 28, 2024 (flooding)

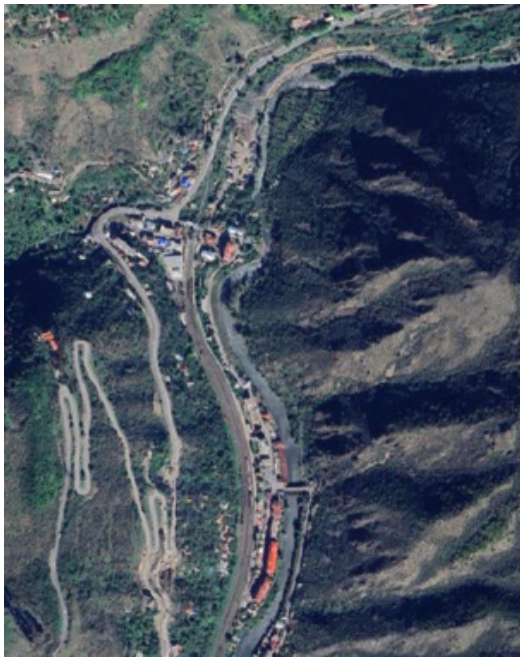
Image 43. Alaverdi Southern Area: April 2023 (comparative).

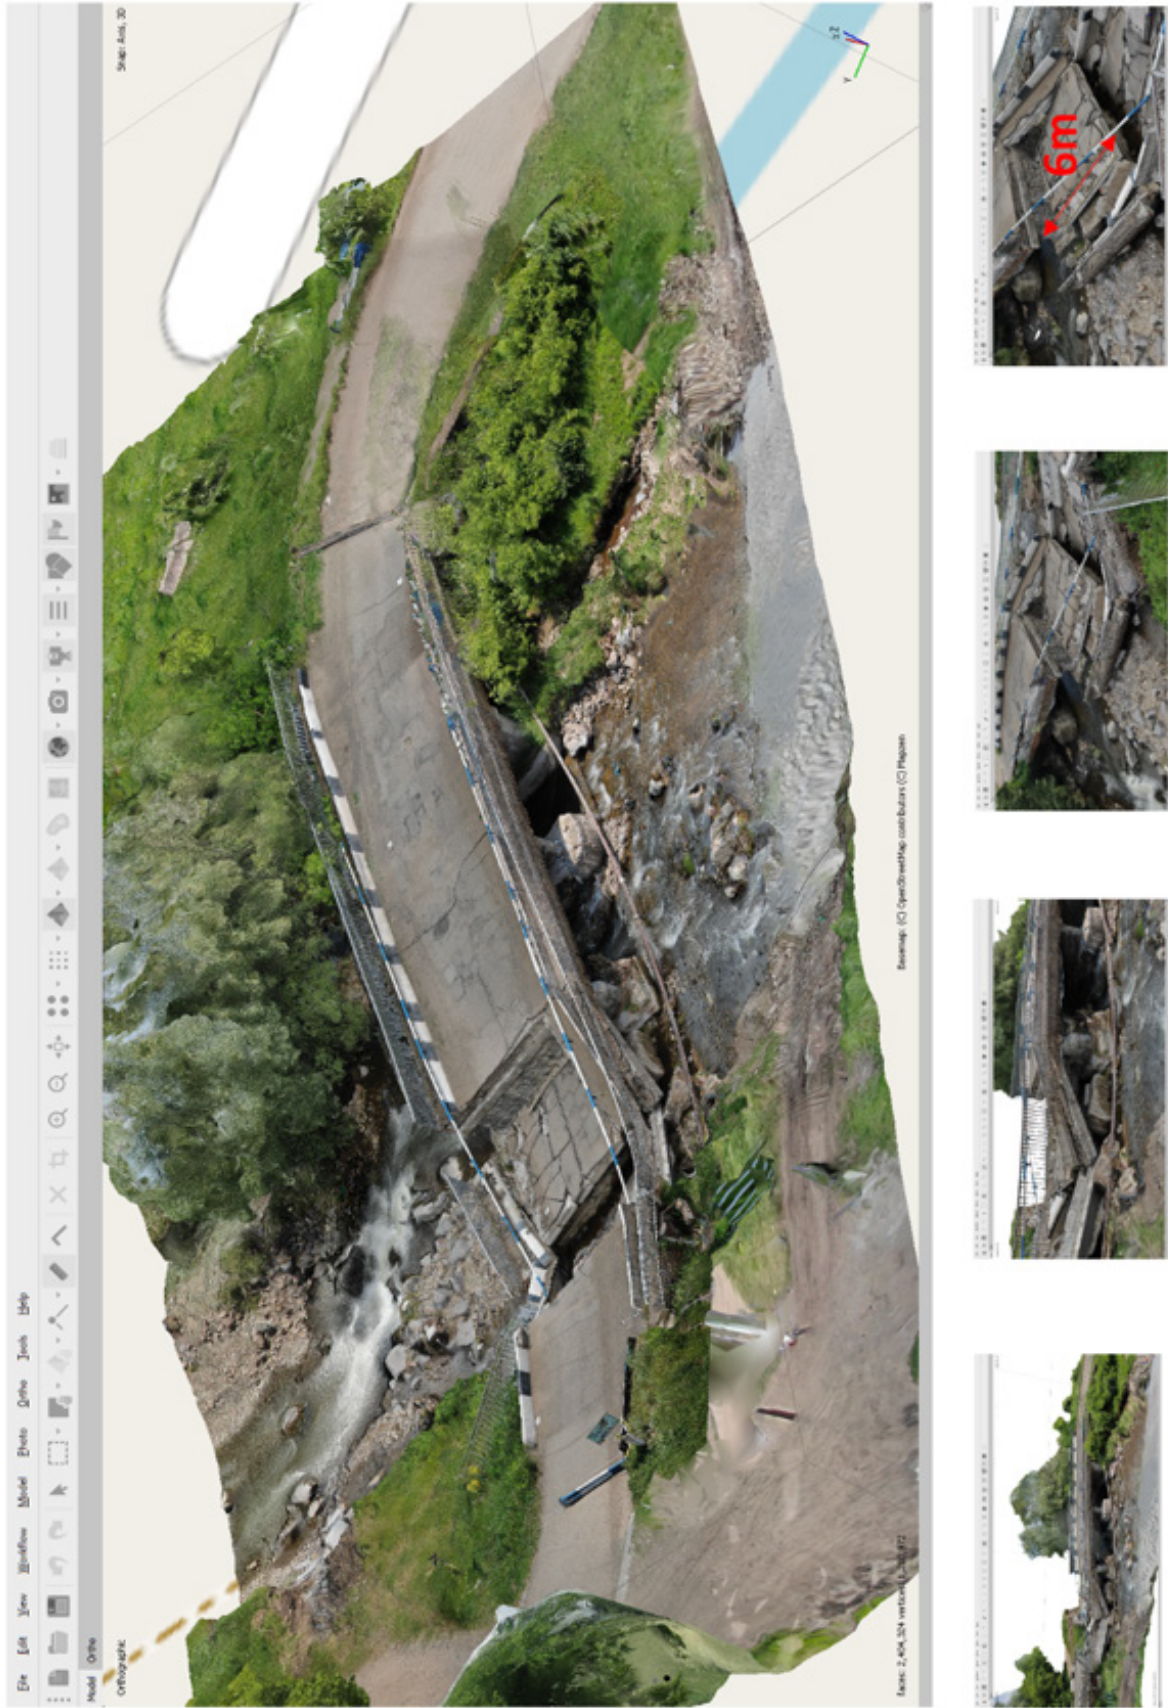
Figure 25. The 3D model of Hobardzi bridge.
